# PHASE I ENVIRONMENTAL SITE ASSESSMENT REPORT & VAPOR ENCROACHMENT SCREENING

**Dukeland Community**
**1700-1715 & 1801-1821 GERTRUDE STREET**
**2815-2827 WESTWOOD AVENUE**
**BALTIMORE, MARYLAND 21216**

**Report Date: June 28, 2023**

**EHC Job Order No.: 052-H**

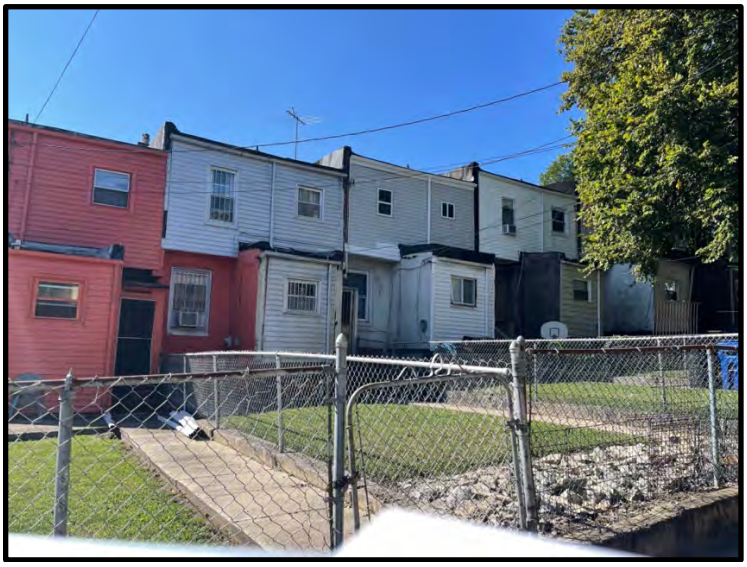
Dukeland Community Entrance

Property to the South

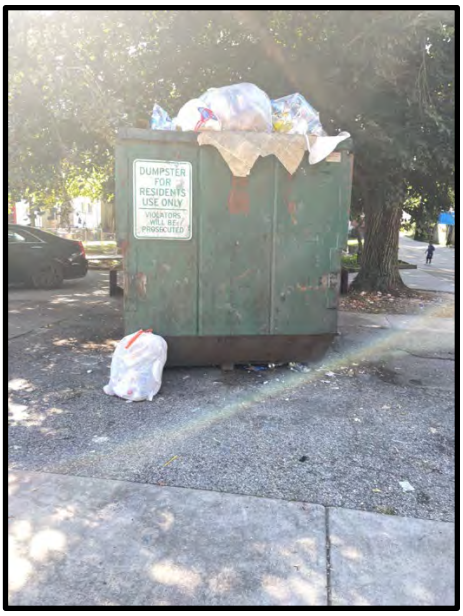
Typical kitchen

Overflowing dumpster (one of five)

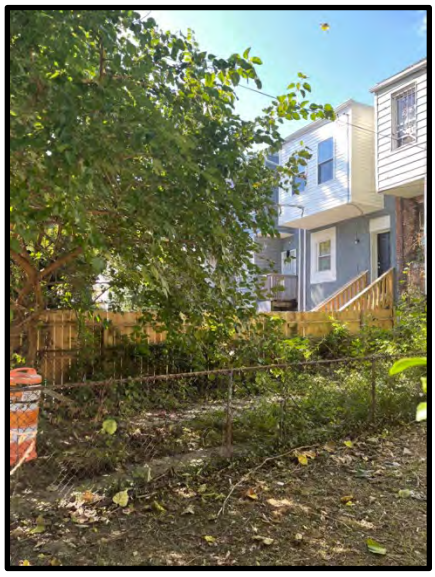
Eastern Boundary Adjacent Property

Northern Boundary Adjacent Property
